Mission St Maarten – Damage assessment cultural heritage on paper  
Period: 30 October to 4 November 2017

Valérie Martens-Monier, Paper conservator, National Archives Curaçao

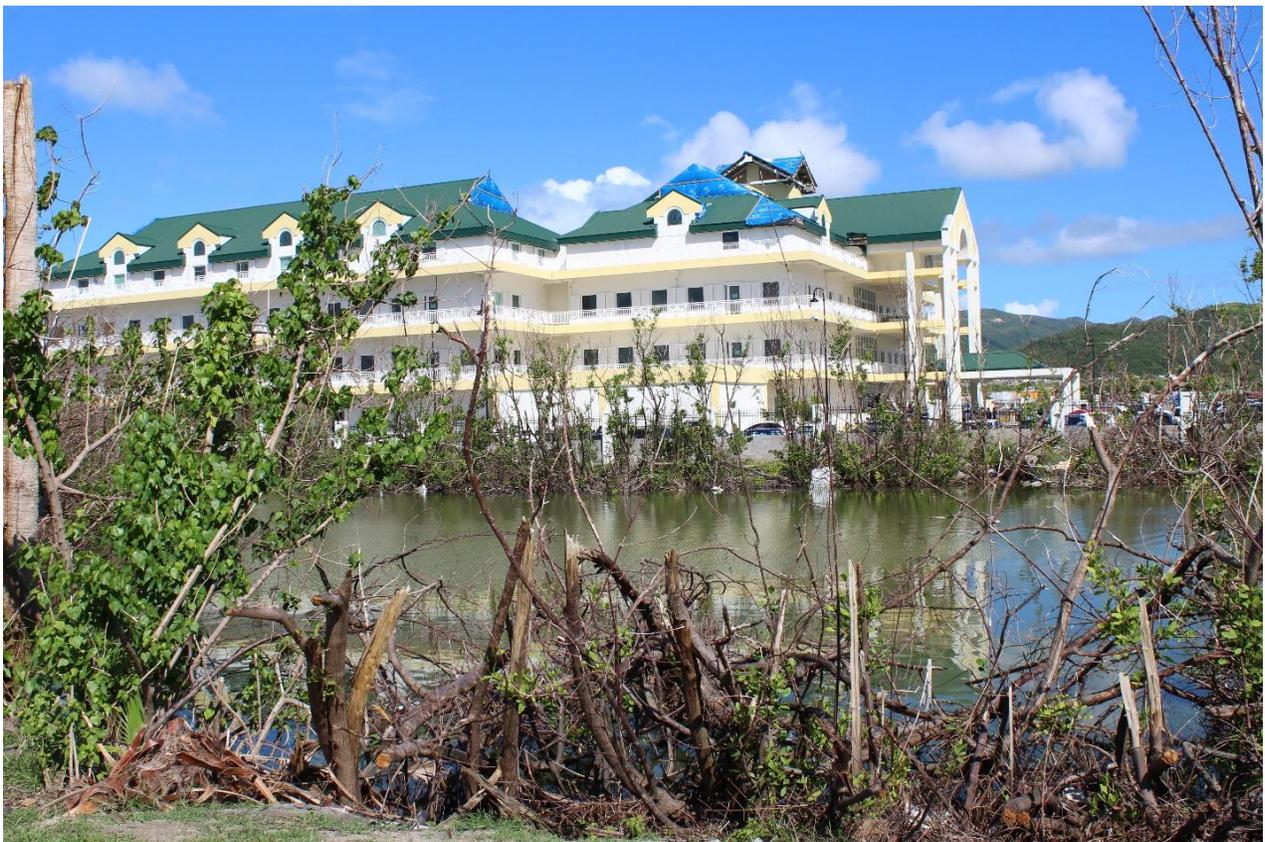
*Figure 2. New government building (NGB)*

The NGB is now dealing with mold growth between the ceilings and this affects the people working there, and maybe the air conditioning system as well. I do not know what type of filters this system has. Something for Marc Stappers, from the interdisciplinary mission, to look into maybe. Of course the roof should be fixed first!

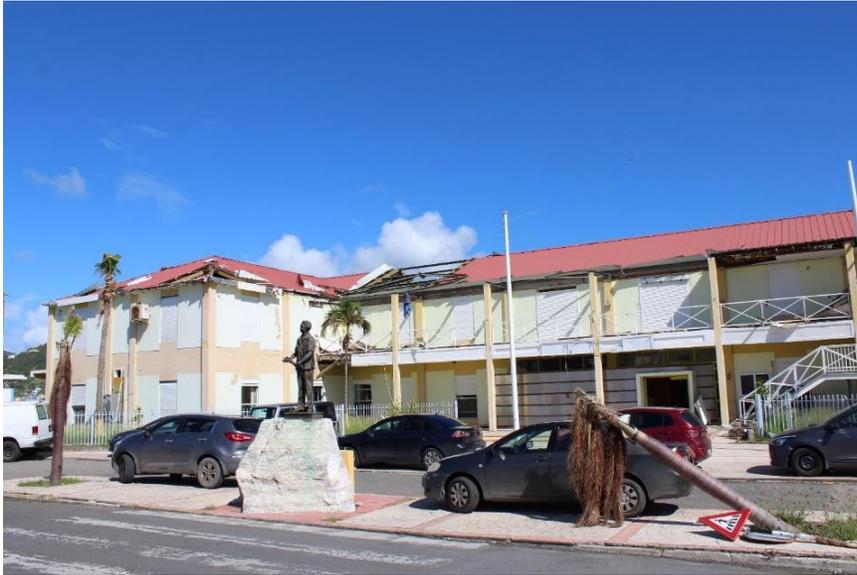
Figure 3. Old government building

The historical archive was still stored in the OGB when hurricane Irma was announced. Despite the fact that this building was partly destroyed, the old archives have suffered no damage because its caretaker, Alfonso Blijden, fearing that the old building might not be strong enough, single handedly took the risk to bring it to his stronger built home, hoping it would be safer there.

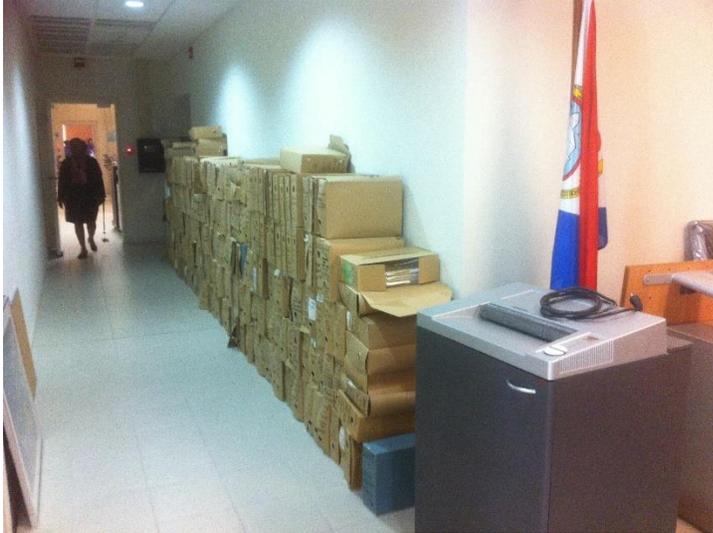
Figure 4. Corridor before the storage unit.

These archives are stored in the NGB in a state of the art storage space with rolling file cabinets and shelving. This room has a separate climate control and fire extinguishing system but unfortunately, the doors have caused some problems, which is why they stay open for now. Its situation is rather unusual as it is located between 2 office spaces from the same department and staff has to constantly walk through the storage.

Once again no meters are available to monitor climate, but I have not met anyone from the Technical staff.

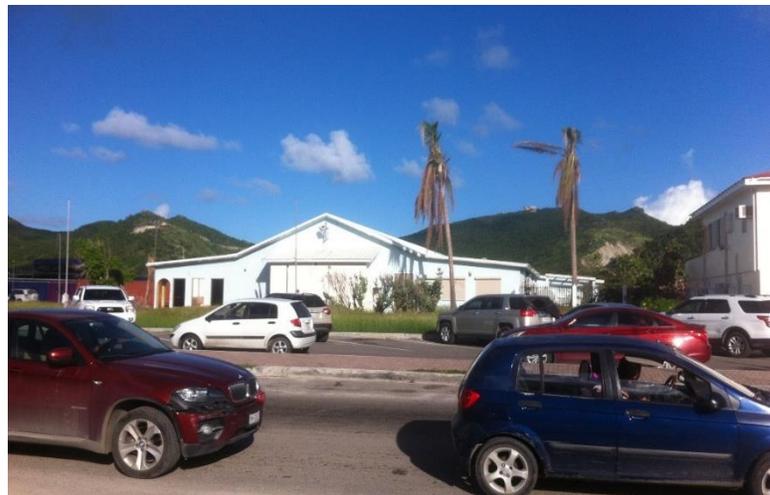
Figure 5. Old building civil registry

The Civil registry was housed in an old building that needed renovation: the building was outdated and there were rodents. Fortunately, this service moved to the new building one day before the hurricane.

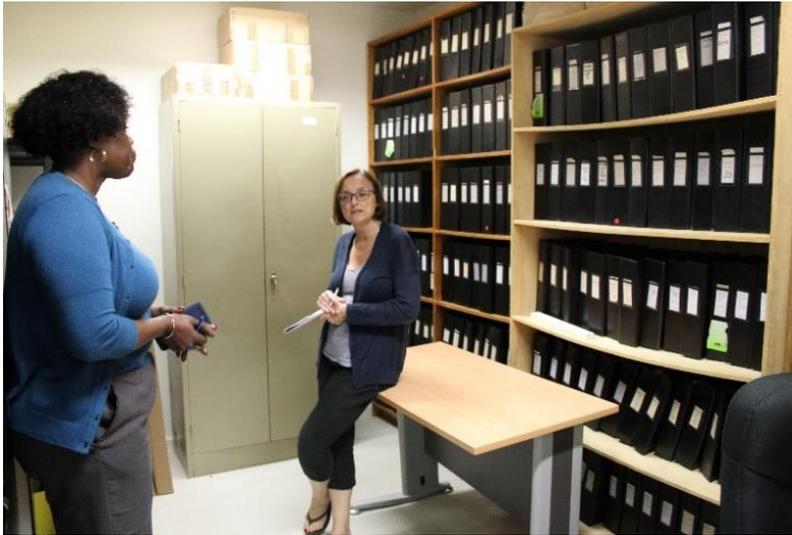
*Figure 6. Recent registers*

The NGB now houses this archive on the ground floor. Registers are temporarily placed on wooden bookshelves and the oldest part is held in metal cabinets. The room is not fireproof but it is air conditioned day and night. They do not seem to have a space reserved in the new storage unit. They are planning to install new metal shelves.

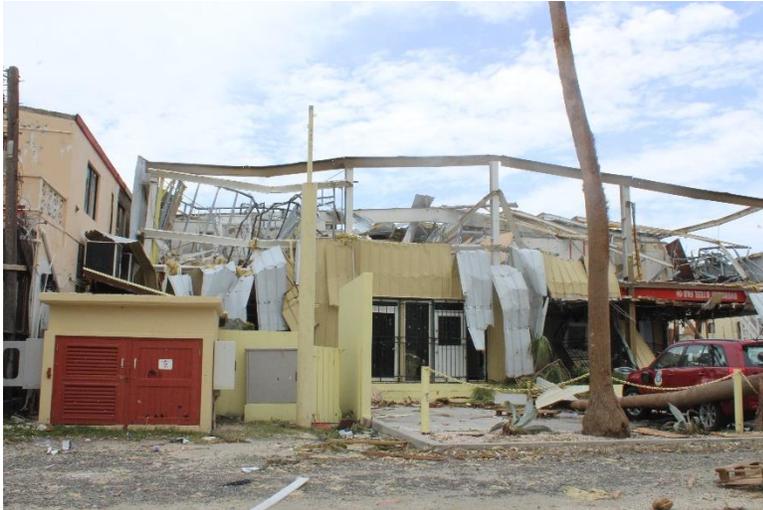
Figure 9. VROMI building after Irma.

The building housing this ministry and its archive was almost totally damaged. Access to the building is still denied for security reasons, as it could collapse at any time. Some (I do not know what exactly and how much) archives that were wet have been packed and brought to the NGB where they are now

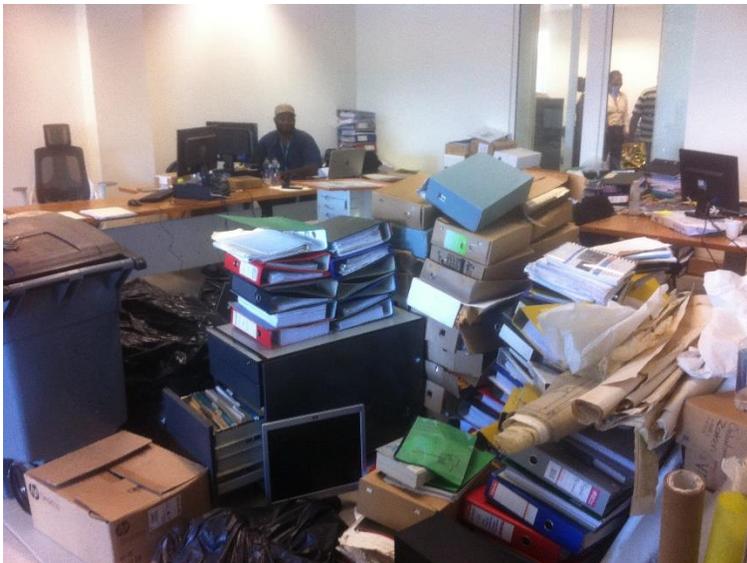
Figure 8. VROMI office in the NGB.

stacked on the floor in the new offices. These documents are dry but often moldy and should at least be packed temporarily to avoid health hazard for the personnel working in the office. No action has been taken so far. It could also become an issue of contamination of the air-conditioning system.

My biggest concern now is the situation in the offices of VROMI where molded documents have been stacked between office desks. I do not know if this has also happened in other services but these objects should be packed and sealed or/and removed from the room.

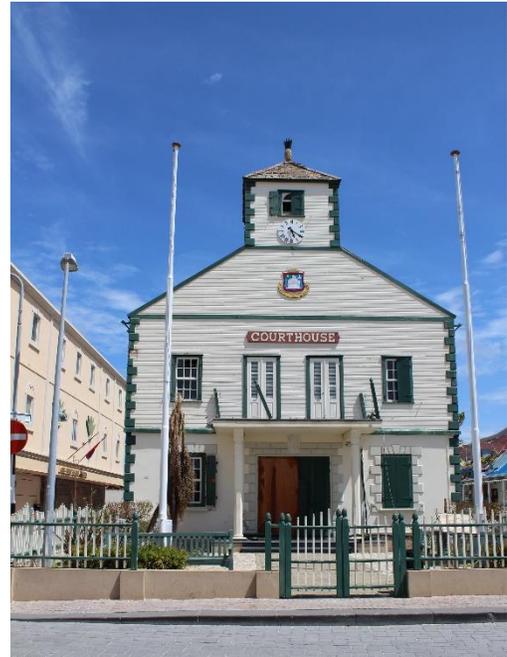
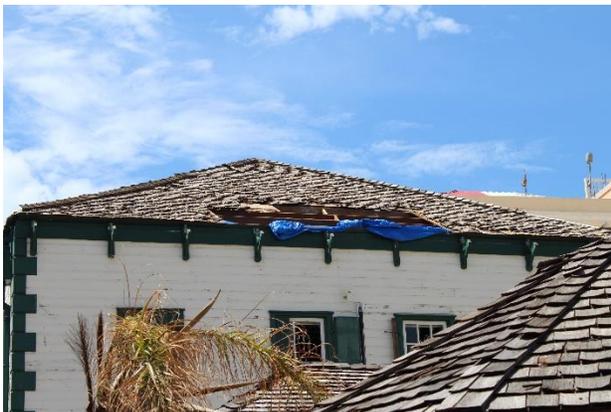
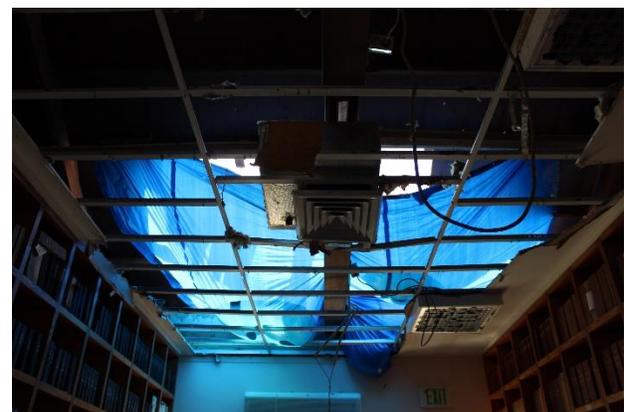
Figure 10. Damage to the Courthouse roof; pictures taken by A.Blijden right after the hurricane

This visit took place on our last day, 30 min before closing time. We did not get any further than the entrance hall of this historical building. Apparently, there was damage on the first floor where the library is situated. Wet books were packed into cardboard boxes and transported to another building, which also stores the archives of the courthouse. We have not been able to visit these archives.

They are now waiting for the roof to be fixed and then the librarian, coming from Curaçao, will assess the situation and select the books that are still usable.

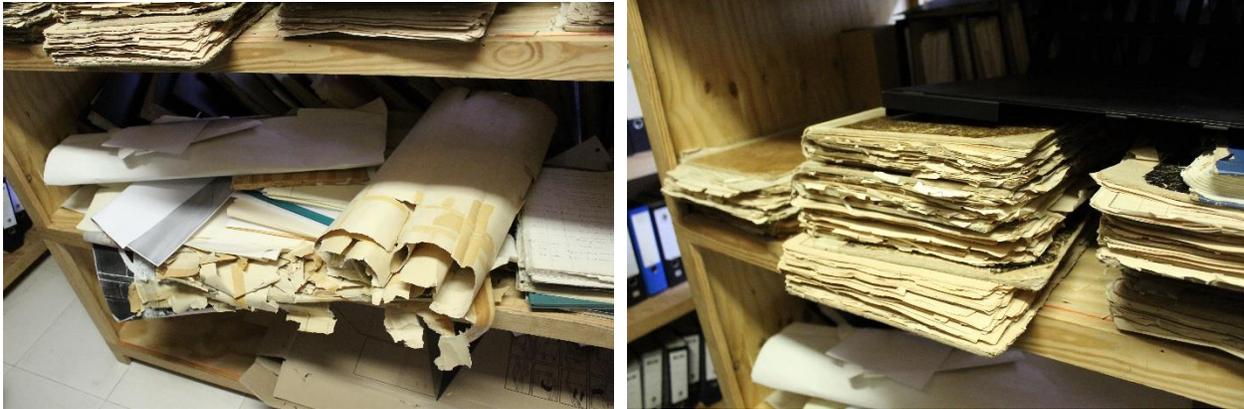
The building is in rather good condition and the roof is intact but some beams have shifted allowing water to enter during the storm. A few centimeters of water covered the floors but has long been mopped away. There is no damage to the documents due to the hurricane but there are concerns about the storage system. There is permanent air conditioning day and night but here again no recordings of

temperature and RH. The wooden shelves must have absorbed a lot of moisture during the minor flooding and the storage room “feels” humid. Objects are lying directly on shelves and are sometimes in very poor condition. The boxes seen are not archival and none of the maps or technical drawings are stored in folders or in sleeves.

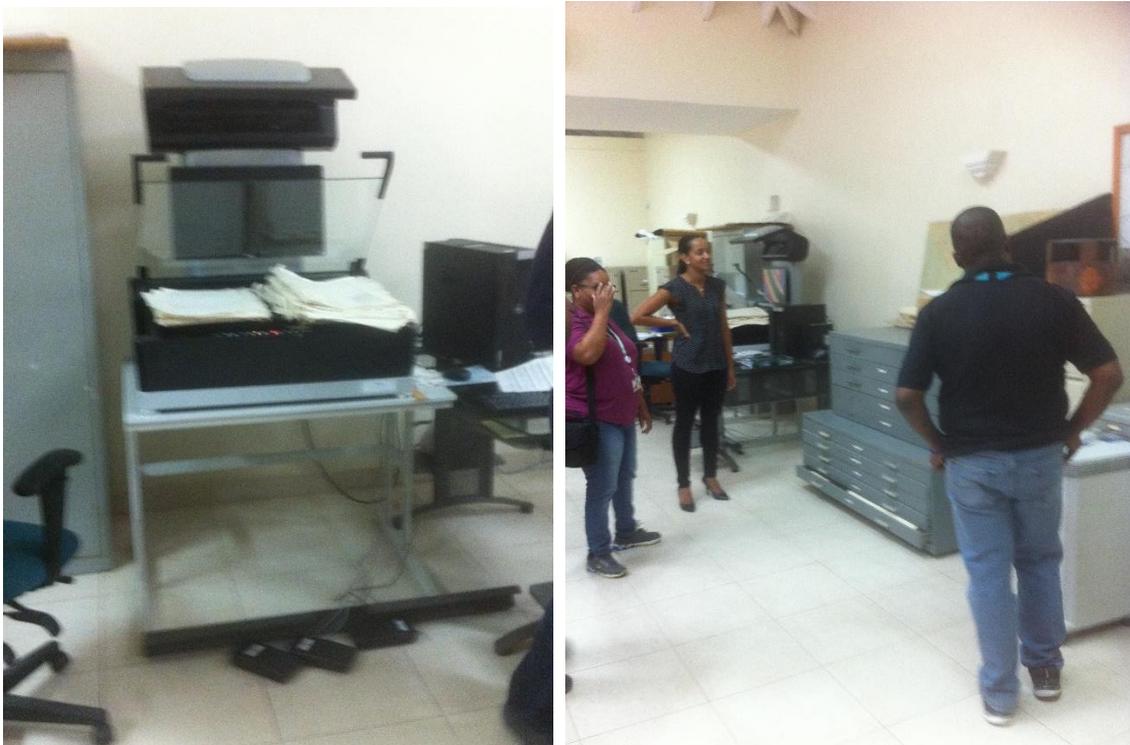
Figure 11. Scanner from brand Zeutschel

The service has recently acquired a scanner (brand: Zeutschel) to digitize its most fragile documents in order to prevent further damage

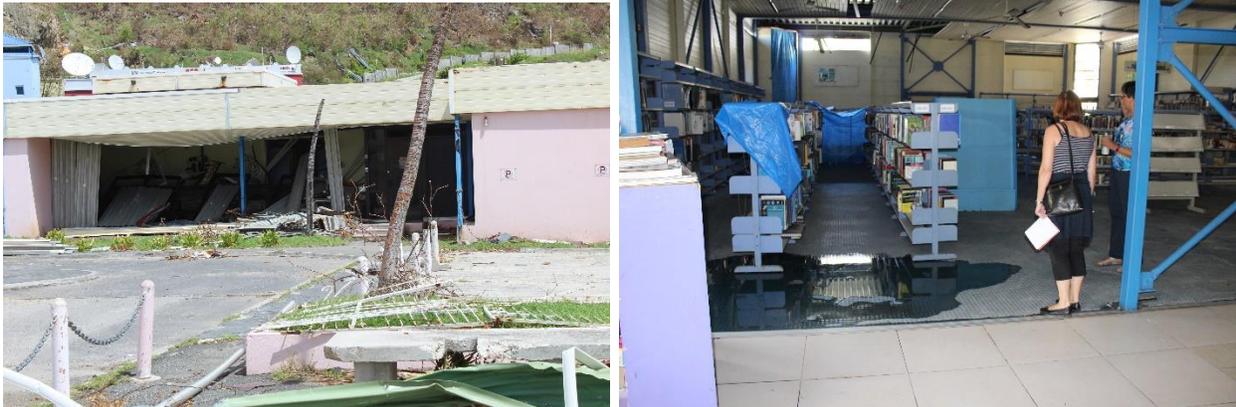
Figure 12. Entrance (a few days after the hurricane) and inside the library

The library building is declared total loss and should be torn down. It is amazing that it is still open to the public. The central part of the building, which still has a roof, stores what is left of the book collection between pools of water. Many books (amount unknown) have been thrown away.

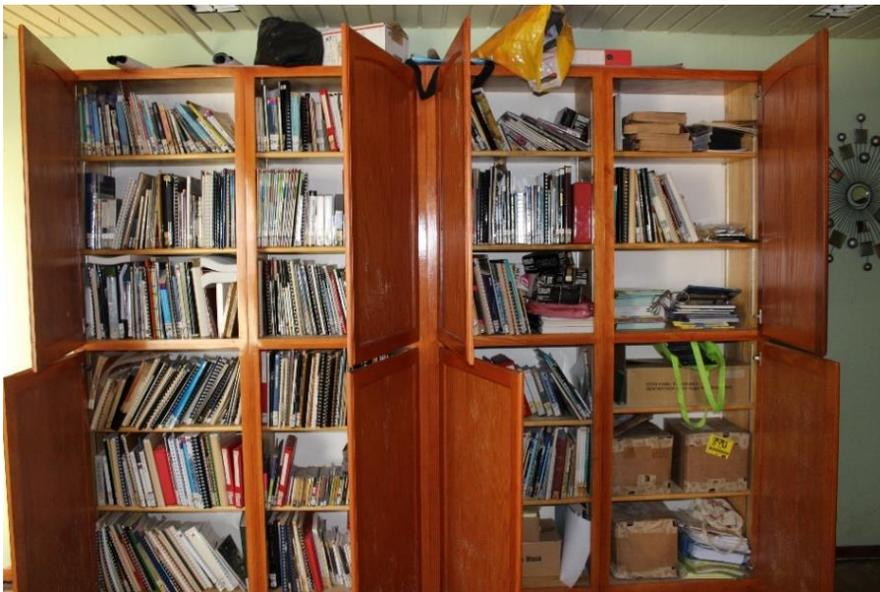
Figure 13. St Maarten collection

The so-called St Maarten collection survived the damage by being stored in a wooden cabinet with closed doors in one of the offices. My concern was that the collection was not in a safe environment because of the lack of climate control and the cabinets were resting on a layer of wet carpet.

This collection will be sent shortly to the NGB. A. Blijden kindly provided archival boxes to store all the documents and an agreement has been signed between the 2 parties for temporary storage.

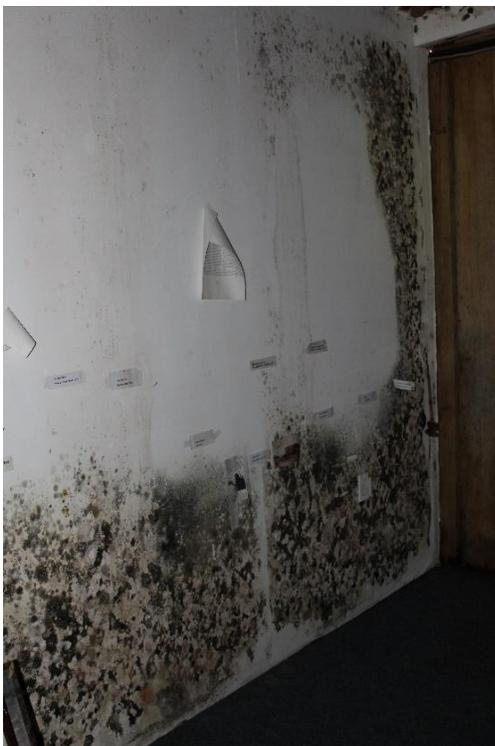
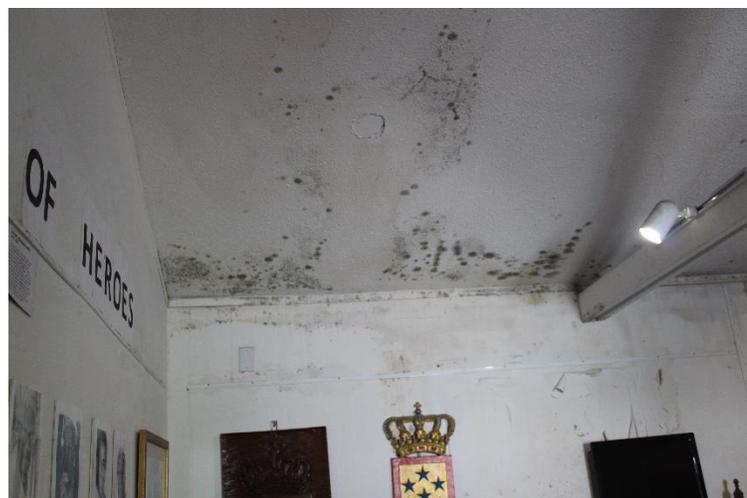
Figure 16. First floor museum

The building suffered damage to the roof. Zinc plates were blown away as well as gutters between the museum and the building situated behind. The wooden beams and sheetrock were still in place but could not prevent the rain from pouring in the top floor of this old historical house. Because the gutter was broken, water infiltrated the walls and caused mold growth in the sheetrock. Rain has poured over bookshelves and the wet books have then been stacked up on the vitrines. Some of these books were still moist and had mild to severe mold growth. The floors are covered with carpet which dries slowly and where mold can grow too. First aid given to this collection is described further on.

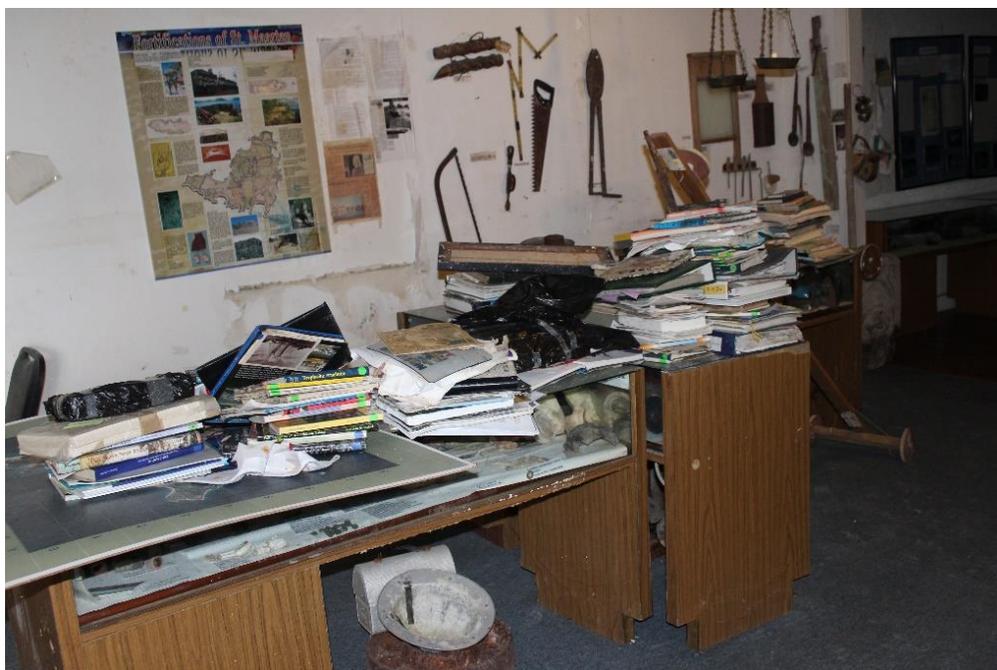
Figure 17. Books piled up on horizontal vitrines

My first concern was for the historical museum where piles of (some still damp) books needed to be sorted. We formed a team with Elsje Bosch, Vida Hodge, Alfonso Blijden, Aruska Bell-Marlin and myself wearing basic dust masks and plastic gloves and started working our way through the piles of books and other objects lying on the vitrines.

The books were separated in five stages of damage. Unsalvageable or easily replaceable books were photographed, listed and thrown away. Damp books were taken outside on the balcony and if possible, they were fanned out to dry. I also showed how to use copy paper and absorbent paper rolls interleaving them between damp pages to increase the drying.

After the triage (we started doing at the museum) is finished, the most damaged books should be individually examined and sorted again, separating what is replaceable and of historical value. The books that are irreplaceable and considered cultural heritage should then be photographed and damage described as much as possible. Only then can a book conservator make a treatment evaluation.

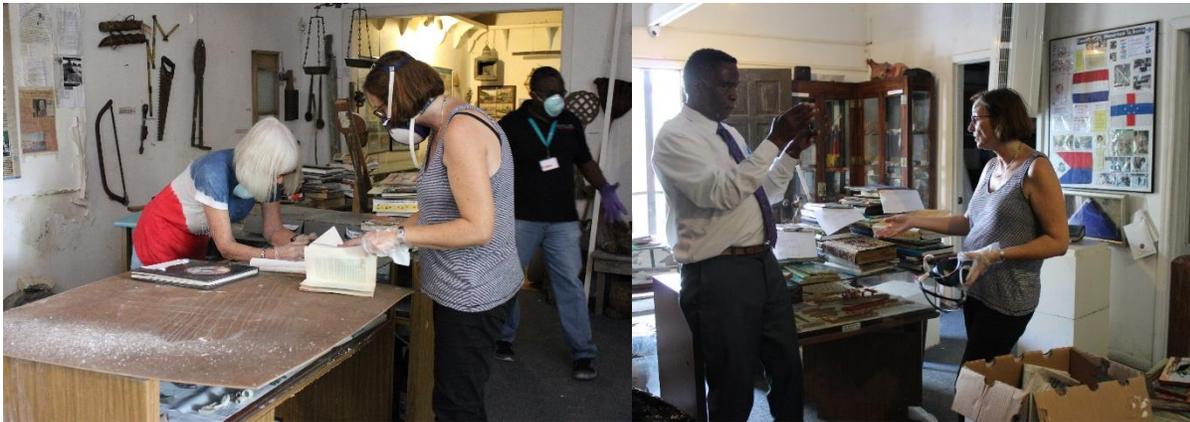
*Figure 18. Assessing damage and Explaining the different level of damage on the books to a reporter*

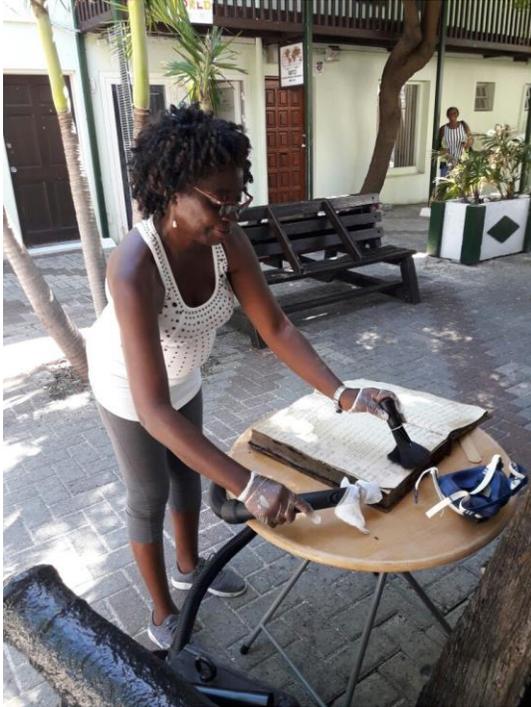
*Figure 19. Vida Hodge vacuuming mold from a 19th century register*

Another demonstration was given (the day before to Vida) on how to get rid of superficial mold growth on dry documents. We used a Hoover, outside because we were not able to get a HEPA filter for this particular model, a gauze to cover the nozzle, attached with an elastic band and a make-up brush to brush the loose mold towards the nozzle. (see figure below)
